Existing Conditions Report and Program Analysis
For The
Town Hall, Fire Department,
Police Department, and Department of Public Works

March 3, 2017

Prepared by:
TBA Architects, Inc.
43 Bradford Street
Concord, MA 01742

Existing Conditions Report and Program Analysis for Town Hall, Fire Department, Police Department, and the Department of Public Works

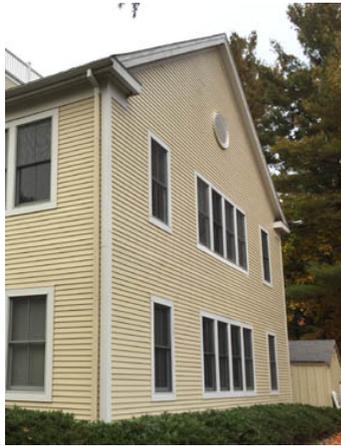
There is evidence of periodic repair on the NE side of the building where trim has been replaced. Some deflection of walls is observed, particularly on the second story central four window unit, which would appear to indicate moisture penetration and some deterioration of sheathing and possibly structural connections.

5. Trim replacement under upper floor, between 4 window units (not visible)

Remove dislocated trim, repair sheathing and framing, reflash, reside.

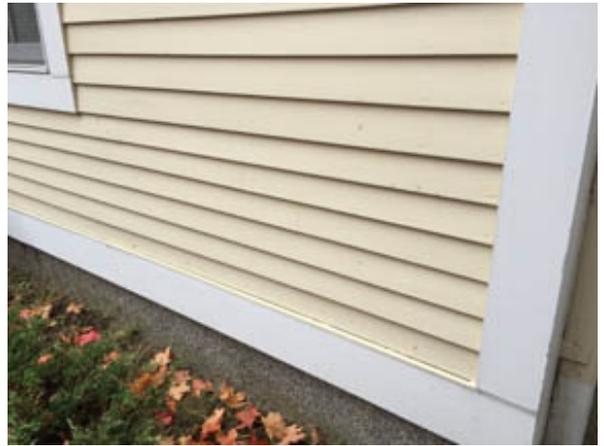
In addition, visible rust of nail heads is observed at the lower several feet of clapboard and trim on the exterior wall in the N/E corner of the building. This may possibly be related to water infiltration associated with the deflection and trim damage mentioned above.

6. Rusted nail heads at building NE corner, lower level.

Treatment Recommendation: Test lower wall section for saturation and, if evidence is found, identify source of water infiltration. If damaged, remove siding, sheathing, insulation; replace, reflash and rebuild areas identified as water source.

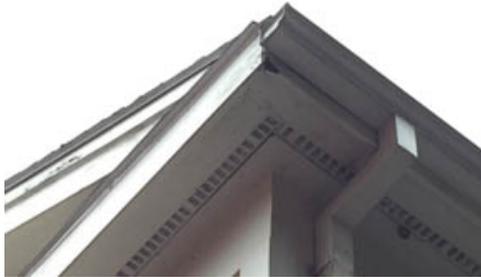
Eave soffits and fascia along the building perimeter show signs of damage associated with backups at gutters, particularly at corners [7]. Soffits have continuous ventilation open to roof trusses.

7. Fascia damage at corner

Repair eaves, soffits, fascia where damaged, reset gutters.

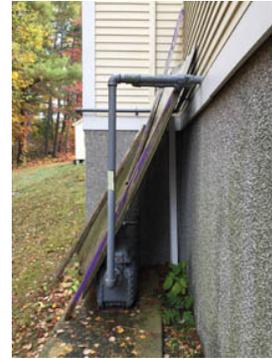
8. Gas meter, makeshift shed

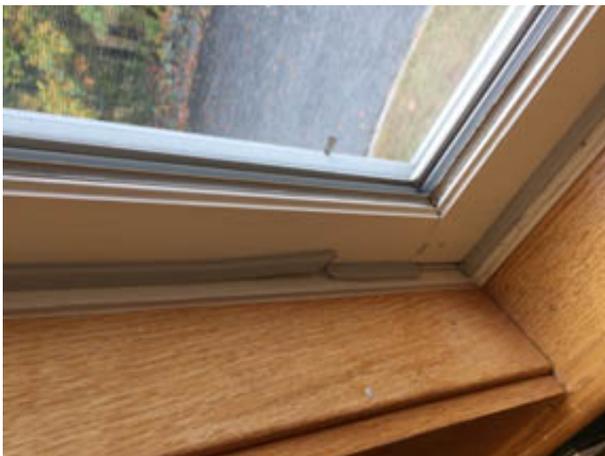
9. Window condition

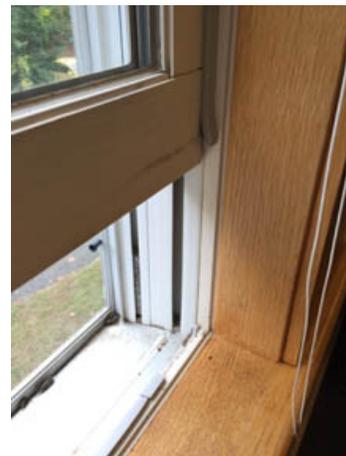
10. Window condition

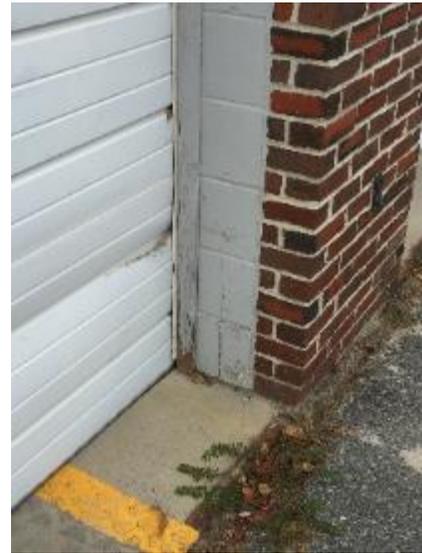
A1010 Standard Foundations: Visible areas of the foundation at the exterior indicate some localized shear failures. Base of brick and block wall systems adjacent to overhead door openings also reveal localized shear failures in the block. It is assumed foundations are fundamentally sound with the minor cracking or settlement failures observed not affecting the basic load carrying capacities of the overall structure.

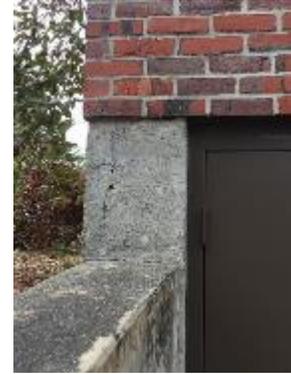
A2020 Substructure – Basement Construction. The South (Front) Elevation is the only portion of the fire station that is built into the ground. The basement wall is a 1'1" thick reinforced concrete wall insulated with 2" of Styrofoam insulation. A significant thermal bridging occurs between the top of the basement wall and the exterior brick and block wall system above where there is no insulation present. The wall appears to be in good condition except at the corner where a shear failure was observed. Failure appears to be due to corrosion around the exposed reinforcing bar (clearly visible). Condition is considered minor but requires repair.

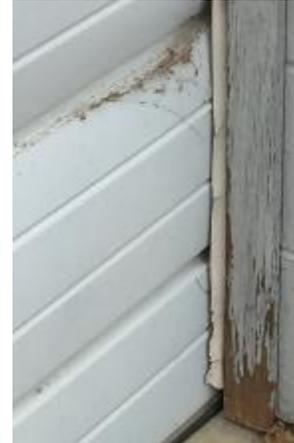
There are seven (7) insulated overhead doors all 14'0" x 14'0". There are four vision panels in each door. Seals have failed in these insulating glass panels and they are fogged by moisture.. All of the doors are motorized. Doors are in good condition, with panel replacements as required in the past. There are no reports of malfunction. The door seals have failed in most locations

1. Main entry aluminum entry door and sidelights are single glazed. The lobby area is utilized for office work and as such the single glazed entry door system should be replaced with a thermally broken insulated glass system which will increase comfort levels at the lobby.
2. The wood stop trim at overhead door jambs require replacement.
3. Paint the exposed concrete block wall at rear façade.
4. Replace all failed overhead door seals and glazed panels.
5. Investigate the crack failures at the base of masonry piers.

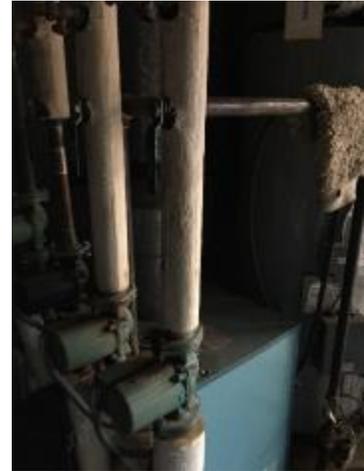
Mechanical Room: The heating plant consists of one (1) gas fired Burnham Model #CF125 boiler original to the building in 1983. The boiler supports four zones via circulator pumps. Zone one supplies heat via unit heater to the locker room and baseboard fin tube to the locker restroom. Zones two and three supply the upper level administrative functions. The entire system is at the end of expected life.

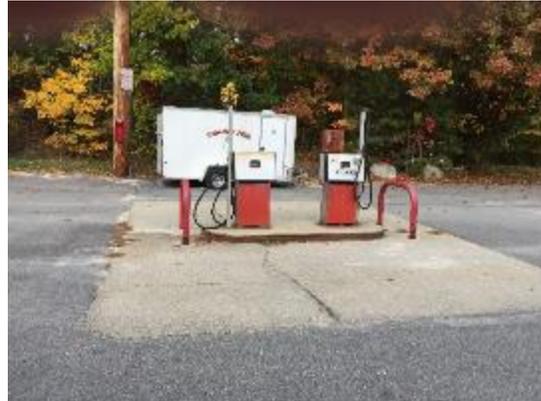
F1020 Special Facilities: The site contains a fueling station with two pumps serving diesel and gasoline. Both fuels are stored in underground, single wall, fiberglass tanks of 2000-gallon capacity each. The tanks are weighted and covered by a 6" drivable concrete slab. The pumps are protected by bollards from side approach but not front or rear approach.

Treatment Recommendation: Install additional bollard protection to front and rear approaches to fuel pumps. Removal of single wall underground tanks is a top priority for the site. Installation of above ground double wall tanks with monitoring alarms is highly recommended (this is already in the planning stage).

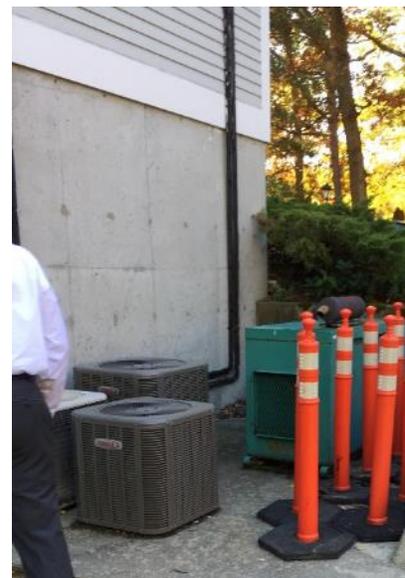
The North (Front), east and west elevations are the built into the ground. The basement wall is a 10" thick reinforced concrete wall insulated with 1 1/2" of rigid foam insulation. A significant thermal bridging occurs between the top of the lockup ceiling (4" reinforced poured in place concrete) and the basement wall where there is no insulation

present. The wall appears to be in good condition. Crack failures appear to be due to corrosion around the exposed reinforcing bar (clearly visible). Condition is considered minor but requires repair.

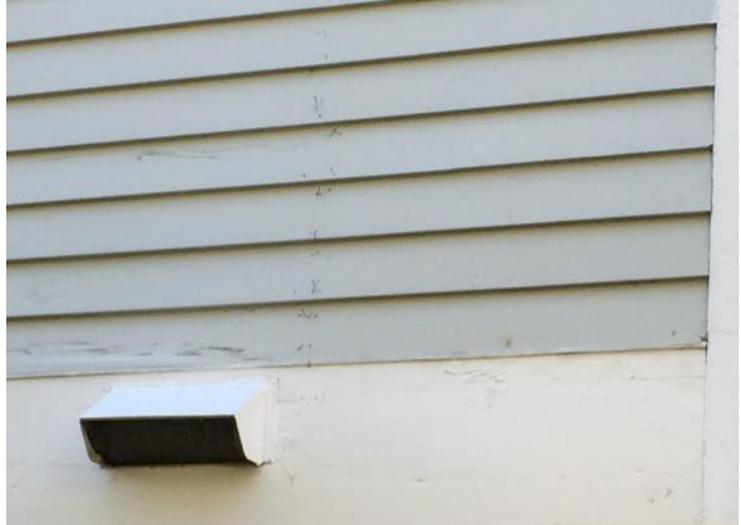
The exterior walls are in good condition with only minor repair and caulking required at this time. The photo illustrates two issues with the wood enclosure. The lowest clapboard and the base trim board are deteriorating due to moisture intrusion. There is also no caulking present at the butt joint between the corner trim and the clapboard. This lack of caulking allows water to penetrate the end grain of the clapboard and hastens the deterioration of all clapboard at each unprotected end of board.

Caulk all joints at time of repainting

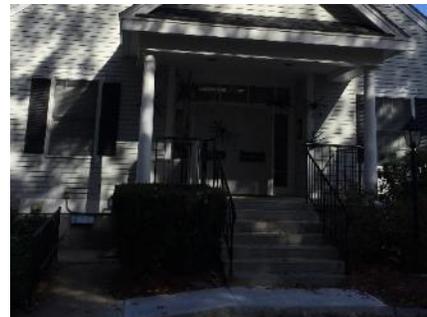
2030 Pedestrian Paving: The concrete paving at the entry and across from the handicap parking spot is in fair to poor condition with some recent repairs. The path is not accessible. Entry steps and pathway steps are not accessible. The main entry stair has vertical risers and the handrail is not properly configured. The handrail is not compliant with code.

Treatment Recommendation: Concrete paving should be replaced with fully accessible route from an accessible parking spot to the front door.

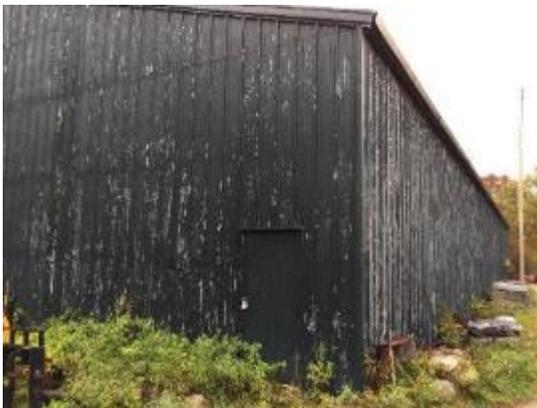
5. Southwest corner – paint failure

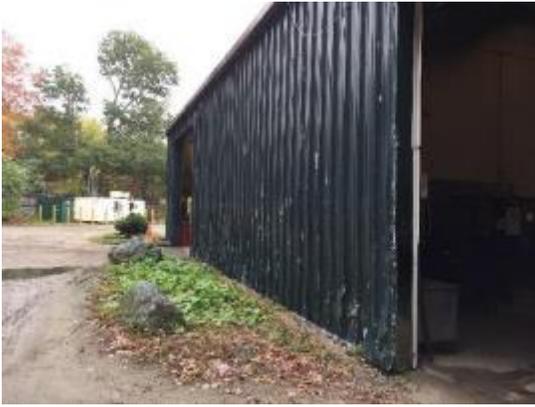
7. Paint failure and damaged cladding

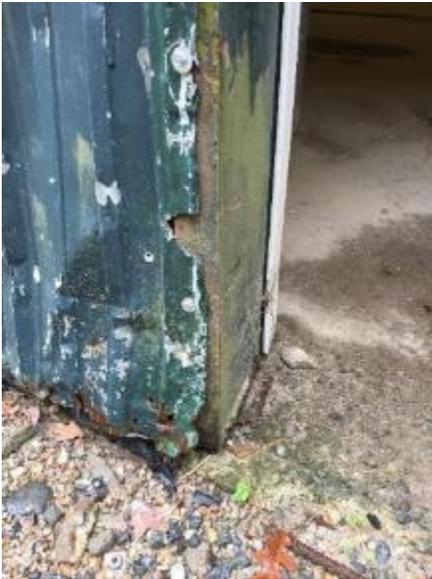
9. Damaged overhead door jamb and slab

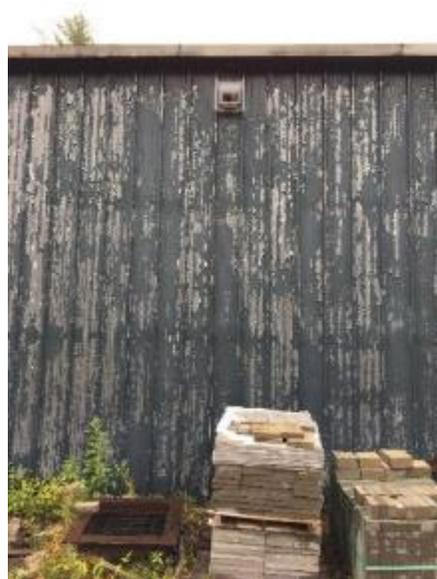
10. Exterior lighting and cladding paint failure

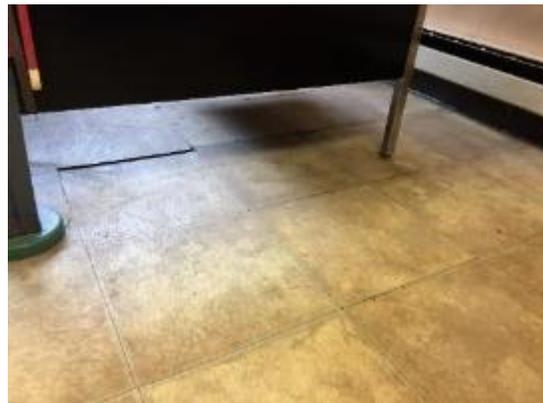
12. Flooring failure at superintendent's office

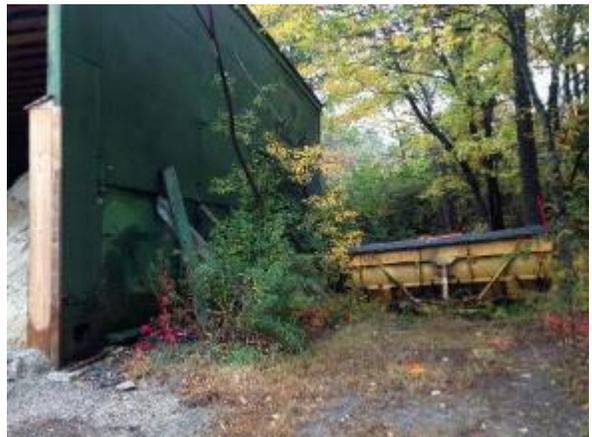
36. Salt shed buttress and sidewall failure

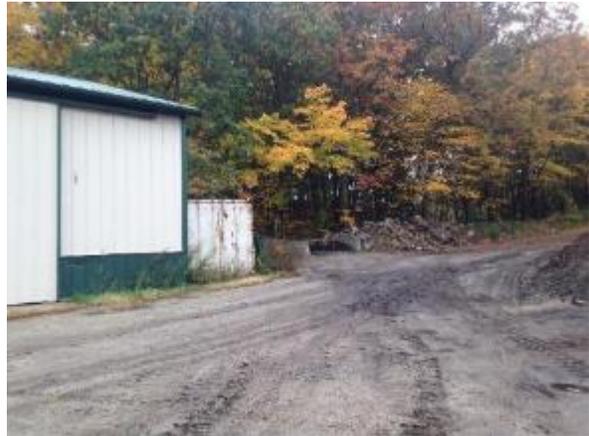
38. Morton building sidewall – damage panel
