HISTORICAL CHRONOLOGY

Engineering Assessment at Central Burying Ground

Carlisle, Massachusetts

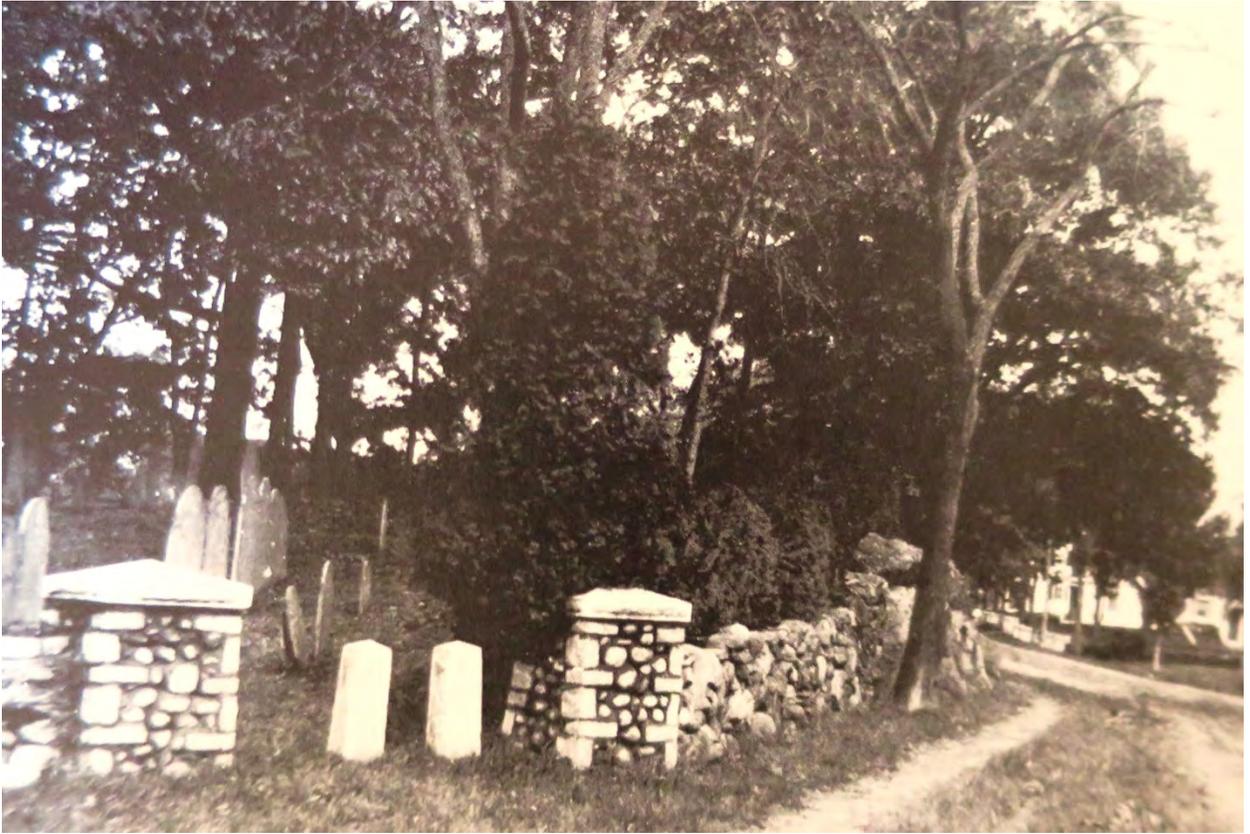
The Central Burying Ground in ca. 1890. The stone posts have been constructed at the southeast corner (1892), but the road and sidewalk (1930) have not been paved. *Images of America: Carlisle*.

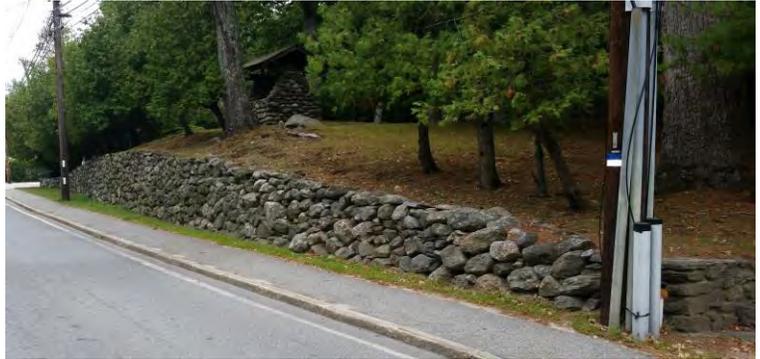
Overall View of Wall

The wall is constructed of dry rubble masonry, made predominantly with granite stones. There does not appear to be any mortar in the wall, with the exception of a small area at the north end, behind the utility pole. The lack of mortar does not in any way affect the structural integrity of the wall structure. In fact, the openings between the stones allow ground water to seep through the face of the wall, thereby reducing forces acting on the rear face. The south end (last 30 feet) of the wall has signs of shifting of stones. This may be caused by the trees behind the wall or by foot traffic.

Structure	Front Retaining Wall
Overall Condition	Very Good

Inspection Items	Comments
Movement	Nothing significant Potential minor bulge near Oak tree (42' from north end)
Joints	Dry rubble masonry - no mortar Some minor pointing at north end (near utility pole)
Staining	Minor staining due to trees and weather
Plant Growth	Minor lichen
Notes	<ol style="list-style-type: none"> 150 feet long Height varies from 2' to 6' Various stone types, mostly granite Aside from one minor potential bulge, there are no signs of movement. Approx. 15 trees located just behind the wall. Possible minor sink hole near the Oak Tree (42 feet from north end) Older trees have been removed. Stumps still present.
Short Term Repairs	Remove trees behind wall
Long Term Repairs	Re-built southern 30 feet of wall Remove mortar near utility pole Clean stone

The trees behind the front wall and entry gates will continue to cause problems over time. All of the trees within 10 feet of the wall and entry posts should be removed, including the root masses (if possible). If the trees are removed, the minor bulge in the wall can be left as is. The bulge will not affect the structural integrity of the wall.

The granite stonework can be cleaned with masonry cleaners. It should be noted that this recommendation is cosmetic in order to remove staining. Cleaning will change the appearance of the wall, which might not be desirable. Some owners prefer to leave the staining as a historic feature.

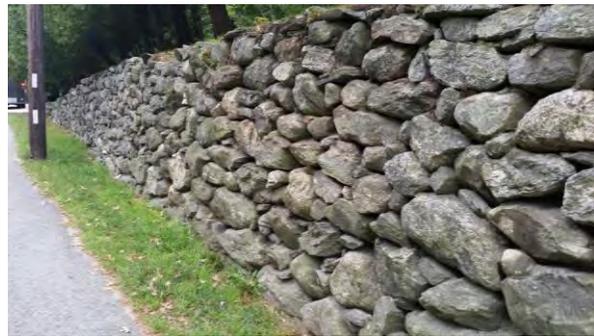
Tallest Portion of wall (potential bulge)

The discussion in this section pertains to the minor bulge in the front retaining wall. The most common causes of retaining wall failures are inadequate design, poor backfill soils, excessive ground water, tree root masses, and unstable foundations. The force from soil exerted on a retaining wall is similar to the force of water acting on a dam. The soil is pressing laterally against the back side of the wall. The force from a tree root mass is similar. As the tree grows, the root mass expands, pressing on the rear face of the wall. If the wall is not massive enough, these pressures will cause the wall to slide laterally, bulge, and/or overturn. Forces from frost and groundwater cause the similar lateral forces that can also fail a wall. The bulge of the front retaining wall can most likely be attributed to the effects of the tree root masses. The reasons for this assumption is that the majority of the wall shows no signs of movement, leading us to infer that it appears to be built on a solid foundation on top of non-frost susceptible soil, with proper drainage, and it has sufficient mass to resist the soil forces acting on it.

It should be noted that bulging of a stone retaining wall constitutes a structural failure. Failures of walls take place over a long time and are progressive in nature. As the tree root mass grows, the wall shifts, thereby relieving the force acting on it. Then the tree grows more and cycle is repeated. Once a wall starts to move, it will continue to move until it collapses. This type of failure can take several years, but in most cases, it takes many years (20 to 40 years or more). Removal of the trees should cease any future movement.

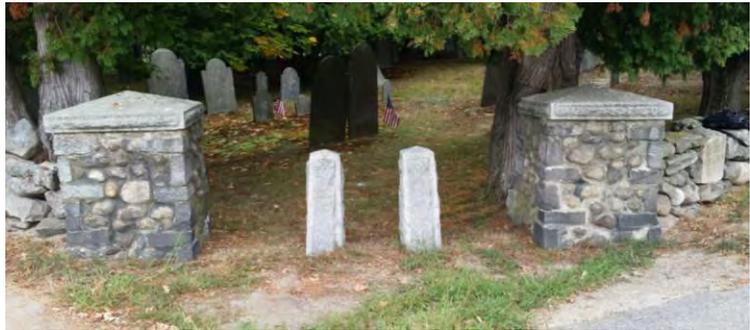
Front Elevation

The south entry gate consists of four features, the two side posts and two center posts. The side posts are constructed with mortared stones. The cap and corner stones of the side posts are cut granite, while the facing stones are rougher rounded stones. There is minor cracking in the mortar joints in the faces of the posts.

Structure	South Entry Posts
Overall Condition	Very Good

Inspection Items	Comments
Movement	Potential minor tilt of left post
Joints	Mortared stone joints Minor cracking in some joints
Cap stones	Good condition
Staining	Moderate staining on exterior
Plant Growth	Minor lichen growth
Notes	<ol style="list-style-type: none"> 1. Granite cap and corner stones 2. Rounded rubble stones on interior faces 3. Minor tilt to left post 4. Tree growing into right post 5. Pointing has been re-done several times 6. Center posts do not appear to be of the same age as the end posts
Short Term Repairs	Remove trees
Long Term Repairs	Reset lean only if conditions get worse Re-point mortar joints properly Clean Surfaces

The cracks in the mortar joint should be repaired by removing the mortar and replacing it with new mortar (re-pointing). The goal would be to prevent water from infiltrating the cracks, causing larger spall during freezing cycles. The re-pointing process would not result in a change to the appearance of the posts. The joints could be cleaned and properly re-pointed with a quality mortar. It is important to not use cement based mortars, which are much stiffer than the older historic mortars. The US Department of the Interior's *"Preservation Brief for Re-pointing Mortar Joints in Historic Masonry Buildings"* should be followed. This document generally recommends the use of a mortar that contains 1 part cement to 1 part lime combined with 5-6 parts sand. The color of the sand may be important if some of the older mortar it to remain. Sand color can affect the color of the final mortar. If all joints are to be repointed (which is most likely the case on the posts, the color may not be as critical.

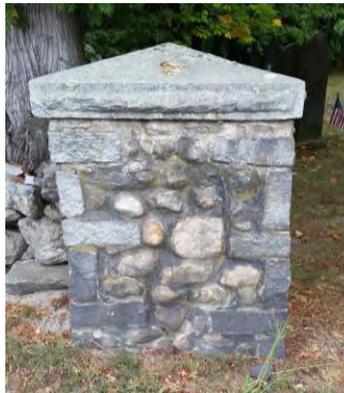
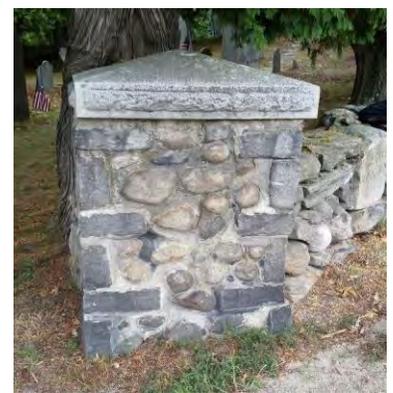
Close up of posts

The left post has a slight lean. The right post has a tree that is growing into the side of the post. It does not appear to have moved to post much at this time. Over time, the tree can cause significant damage to the post.

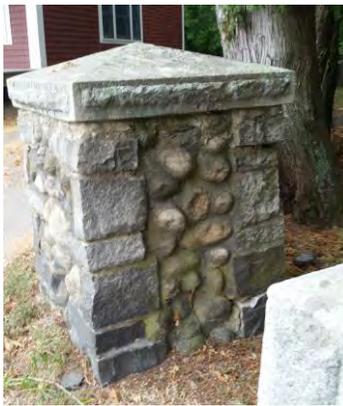
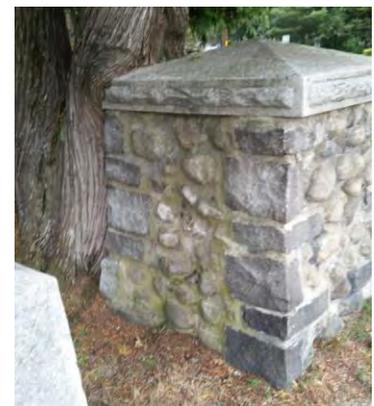
Sides of posts

The cracks and lean of the corner posts is mostly likely caused by one or more of the following:

1. Poor soils beneath the posts leading to settlement
2. It is doubtful that these posts have deep foundations, therefore another cause could be frost action in the soils below
3. Tree root pressures

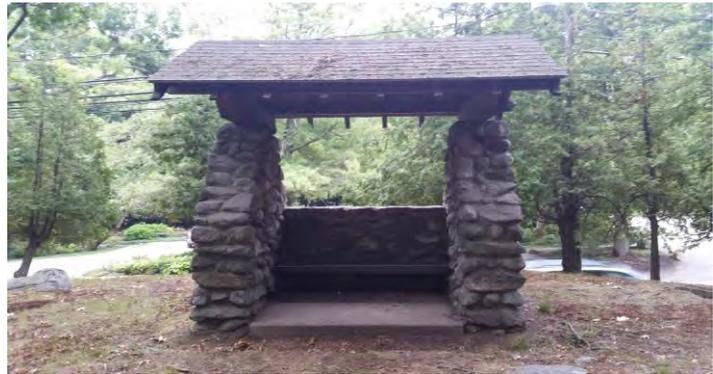
West Elevation

The structure is quite stable showing very few signs of settlement. There are minor cracks in the mortar joints, which could be caused by minor settlement or thermal expansion. There are several areas that have been re-pointed. The color of the pointing does not match the original pointing.

Structure	Litchfield Seat
Overall Condition	Good

Inspection Items	Comments
Movement	No signs of significant movement. One crack in base
Joints	Top portion of rear face have been re-pointed The remainder are in good condition
Staining	Minor staining
Wood framing	Most of the wood is in good condition Several rafters have damaged ends One main beam is severely rotted Minor graffiti carving Needs staining
Roofing	Asphalt Shingle roof (most likely not original) Good condition
Notes	1. Concrete base is in very good condition 2. Seat is in very good condition
Short Term Repairs	Replace rotted beam, repair rafters Fill graffiti carving and sand Clean stone Stain all wood
Long Term Repairs	Replace roofing with appropriate materials Repair cracked pointing Re-point un-matching pointing

The masonry portions of the shelter can be repointed as described above. The newer pointing should be removed and replaced with historically accurate mortar that matches the original mortar. The minor crack can be repaired by re-pointing the joints in the area of the crack.

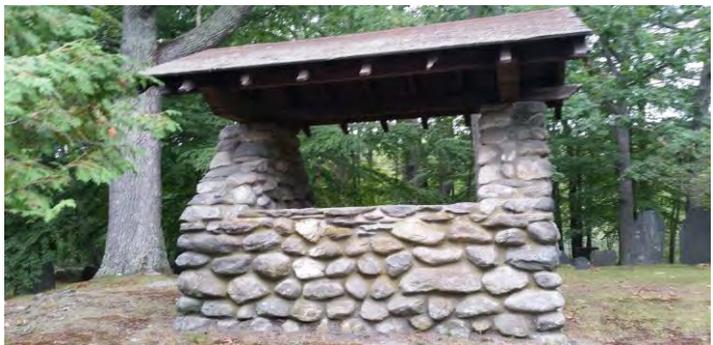
East Elevation

The wood roof framing is generally in fair to good condition. There are several rafters that have broken eave ends. This does not affect the structural integrity, but is considered a visual detraction. The main beam on the east side has severe rot. The ends of this beam are essentially not supporting the end rafters. There is some graffiti carving on some of the wood surfaces.

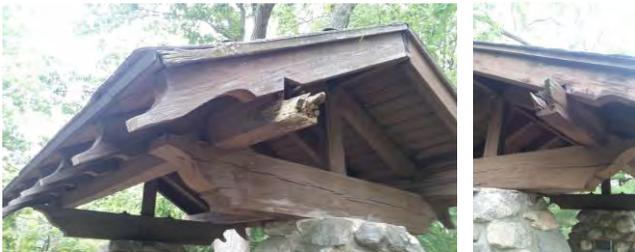
Rotted wood beam on south side

The problems with the Litchfield Seat Shelter can be attributed to normal exposure to the elements. The rotting of the wood is due to exposure to rain and lack of proper stain on the members. The damaged rafter ends could have been caused by vandals. The minor cracking in the masonry could be a sign of a marginal foundation settlement; however it could also be caused by thermal expansion of the structure. Neither of these two causes and the ensuing issues are cause for alarm. The structure, if properly maintained should last for many years.

The shelter is in need of minor restoration. The rotted beam is the only critical element as further decay could lead to more damage and potentially a partial collapse of the roof rafters. The roof can be temporarily supported allowing for removal and replacement of the rotted beam. The details for the new beam should match the original beam (front beam). The rafter ends can either be repaired by scarfing in a new piece, or by replacement with a similar rafter. The detail of the new pieces should match the original design.

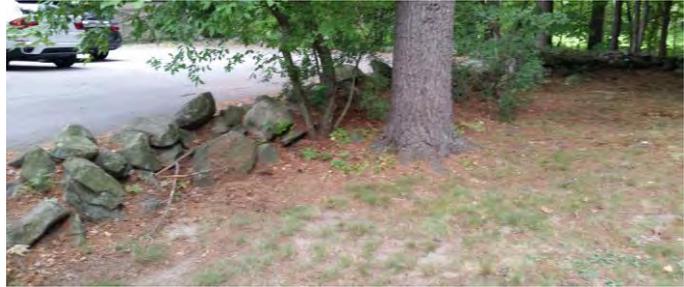
South Wall

The south border, west border, and north border of the burying ground are defined by a rough stone border wall. A border wall (also called a farm wall) is intended to define the border, not retain soil. The border walls in the Central Burying Ground are constructed with loose stacked stones without mortar. They were mostly likely built during the clearing of the land for the cemetery and/or adjacent properties. As stones were dug up, they were stacked along the border to define the limits of the burying ground. It

is our opinion that these walls were never intended to be an architectural feature of the burying ground, therefore they may never have been neatly stacked. Over time, numerous stones on these walls have fallen away onto the ground adjacent to the walls. In general, these walls are in fair condition, primarily due to the scattered stones throughout.

Structure	Border Walls
Overall Condition	Fair

Inspection Items	Comments
Movement	Many stones have shifted
Joints	Dry rubble farm wall, no mortar
Staining	Significant staining
Plant Growth	Lichen growth
Notes	1. These walls are considered to be farm walls. They were never intended to be architectural. They were most likely built from stones unearthed during the clearing of the land and during excavations for graves.
Short Term Repairs	None
Long Term Repairs	Reset fallen stones

The shifted stones can be repaired by careful dismantling and restacking the stones.

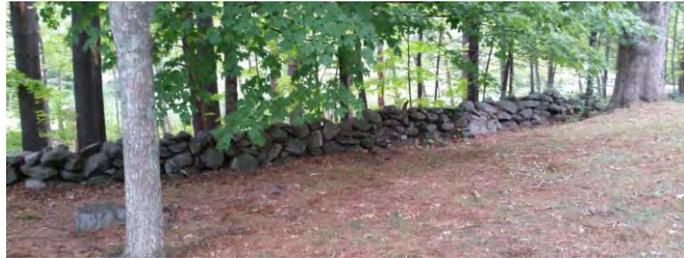
West Wall

The falling stones on the border walls do not indicate a structural problem. It is mostly likely caused by one or more of the following:

1. Snow and ice build-up that can push stones away from their seats
2. People scaling the walls and dislodging the stones
3. Frost action leading to shifting of the wall

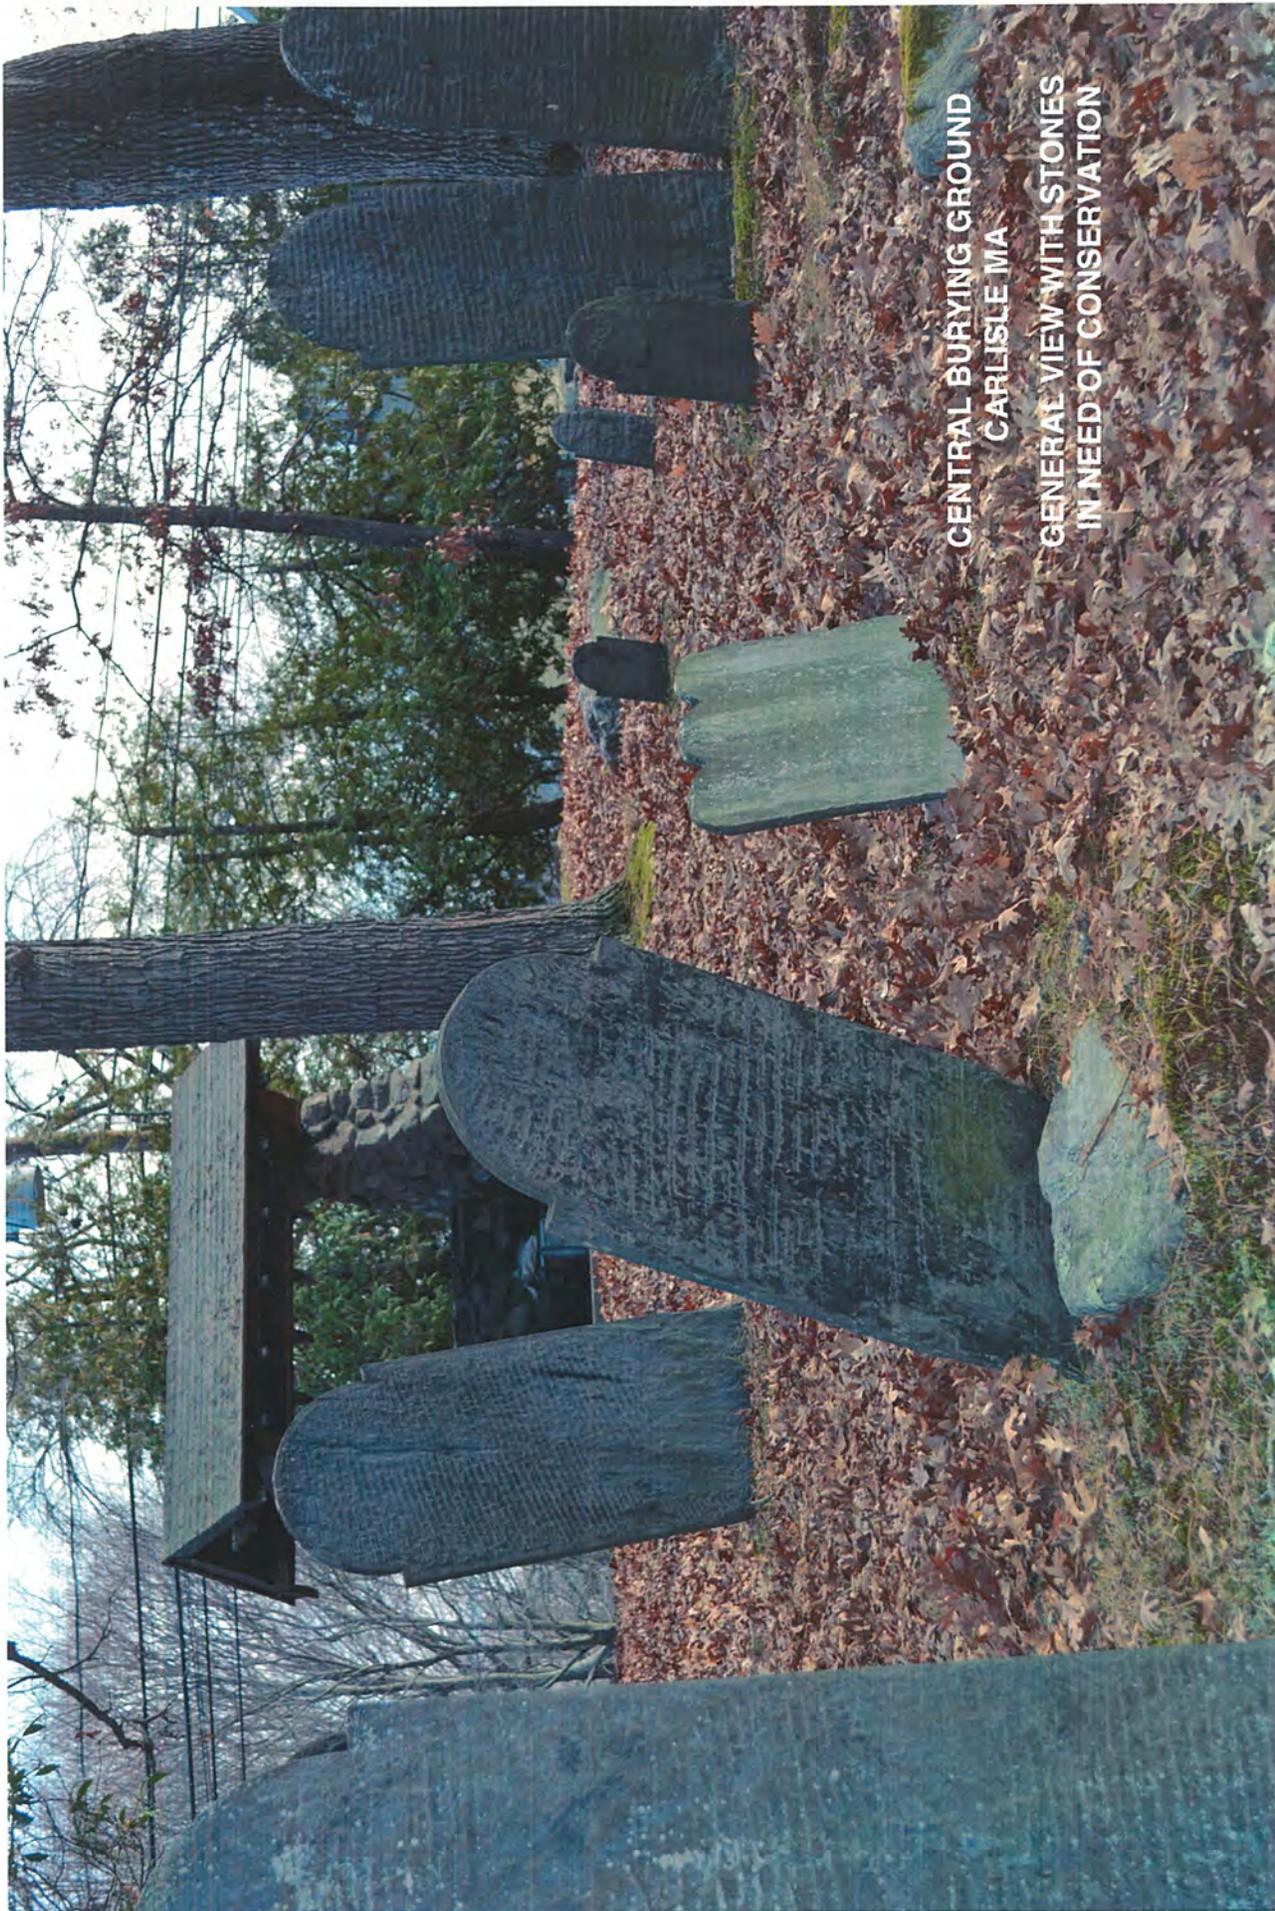
CENTRAL BURYING GROUND
CARLISLE MA
GENERAL VIEW WITH STONES
IN NEED OF CONSERVATION

However, these historic gravestones suffer from a number of problems that should be addressed in order to extend their lifespan. Among issues found during the assessment were stones severely tilting, numerous markers raised far above the original setting line, trees and tree roots capturing gravestones, severe coatings of lichenous growth obscuring inscriptions, delaminations, missing top fragments and markers rubbing together causing chipping.
