Article 7: Motion Three, Restoration of Greenough Dam.

Description of Greenough Dam and Need for Repair

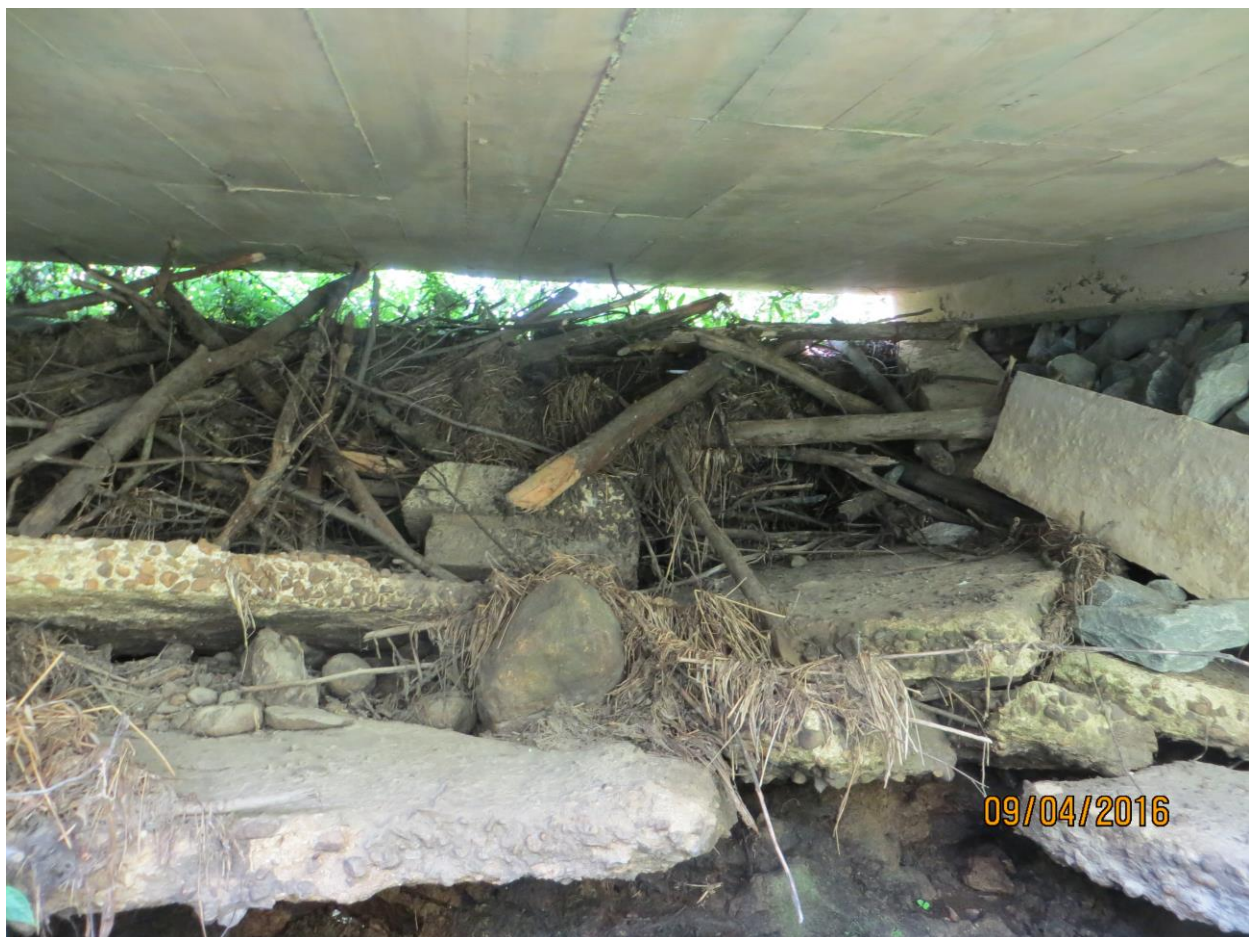
Underside of Spillway #1.

The Greenough Dam was built nearly 100 years ago and is a 300-foot long earthen structure, 6-foot high with two concrete spillways: Spillway #1 and Spillway #2. From 1984 to 1995, Greenough Dam suffered recurring problems and dam failures, requiring substantial stop gap repairs to the earthen part of the structure.

An engineering evaluation required by the Office of Dam Safety on October 20,2000, nearly twenty years ago, determined that the dam was in fair to poor condition and the spillways had inadequate discharge capacity.

The Town and the Conservation Commission undertook some recommended actions, including the funding of a Hydrologic and Hydraulic (H&H) Study and the preparation of design documents. The Carlisle Trails Committee removed the trees to help prolong the life of the dam. The dam has continued to decline. High water has overtopped the dam occasionally causing erosion. Spillway #1 has significantly deteriorated and is now in failure. It has a crumbled and broken concrete floor. The deck's upstream and downstream center-supports and portions of both of its walls are missing are presumed to be downstream toward the Concord River. Spillway #2 has also experienced some decline in the last few years and now requires a new deck.

The dam project includes installation of a permanent coffer dam located pond side at Spillway #1 to keep the pond in place during construction and for future stabilization of the structure. Spillway #1 is to be replaced by three, side by side box culverts set at different elevations to improve discharge capacity. Spillway #2 is to receive a new deck. The downstream slope of the dam is to be cleared of brush and any saplings and trees that have become re-established, regraded, loamed and seeded. To compensate for impacts to wetland resource areas two small replication areas need created. Carlisle has all the permits required for the project.
