Existing Conditions Report and Program Analysis
For The
Town Hall, Fire Department,
Police Department, and Department of Public Works

March 3, 2017

Prepared by:
TBA Architects, Inc.
43 Bradford Street
Concord, MA 01742

Existing Conditions Report and Program Analysis for Town Hall, Fire Department, Police Department, and the Department of Public Works

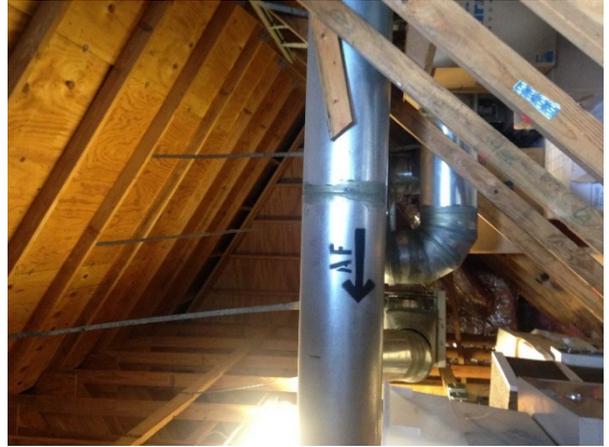
2. Attic Framing

B1020 Roof Construction: The sloped roof sections are framed by dimensional lumber trusses with metal plate connectors [2]. The roof deck is plywood and is uninsulated. The flat roof area for the HVAC core could not be directly observed. Construction drawings indicate it is framed with LVL and TJI members stabilized with steel angles. During inspection the access path around the HVAC units, comprised of EPDM and walkway pads, was spongy underfoot [3]. No leaks were directly observed however the sponginess may indicate water penetration and possible saturation of rigid insulation.

Treatment Recommendation: Sponginess in EPDM indicates possible saturation of insulation under membrane. This should be tested for condition. EPDM roof material appears to be original to the building and is at approximately 75% of life cycle. It should be replaced in coordination with HVAC unit replacement to avoid additional spending in the near term (see D30 below for discussion). If water penetration is observed, tests may be needed to confirm structural integrity of supporting wood deck and structure. As part of replacement, additional insulation may be installed with the new roof membrane to achieve operating savings and bring building closer to current code requirements.

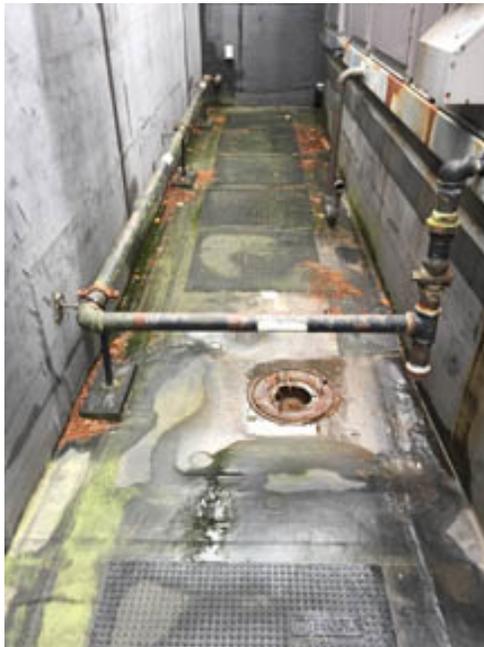
3. HVAC Roof Area

The existing HVAC roof top unit (RTU) is original to the building and should be replaced. Current performance reduces indoor air quality and discomfort due to cold temperatures. There may be saturation of wall and roof insulation which should be tested.

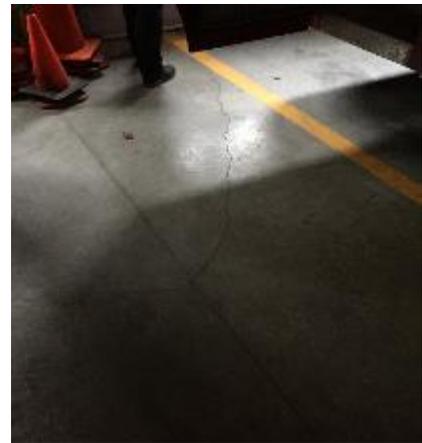
A 1030 Slab on Grade: The lower level floors are 6" thick slab on grade reinforced with WWF (welded wire fabric) 6-6 x 10 /10. Concrete slab floors in the garage bays, utility rooms and storage areas are in fair to good condition with expected wear and cracking. Slab cracking follows a diagonal line from garage bay doors inward to original control joints. The cracking appears to be the result of the lack of a thermal break between the floor slab and the exterior apron as well as the heavy loads imposed by newer equipment at the apron and entry section of the slab. Concrete slab is under various floor finishes, from sealer in the equipment bays and vinyl sheet in the locker room and kitchen. There are no signs of unexpected deterioration in areas covered by sheet vinyl floors, so those slabs areas are assumed in fair to good condition as well.

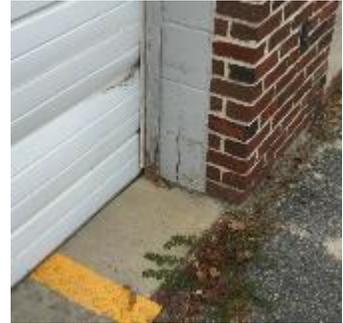
B2010 Exterior Walls: Walls are in good condition with the exception of the basement wall at front eastern corner where spalling has occurred and at the masonry piers at the eastern façade.

1. The spalling at the front of the basement wall appears to be the result of corrosion of the reinforcing rod that was left exposed. (See paragraph A2020 above)
2. The base blocks of the masonry piers have cracked at each pier location. This condition does not exist on the western façade. It appears that a combination of thermal stress and loading stress contributed to the failures. Destructive investigation is required to determine the extent of the failure and best remedy.
3. Wood stop trim at the overhead doors has deteriorated especially at the bottom sections.

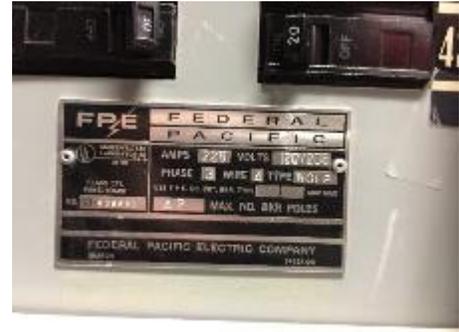
D5010 Electrical Distribution System: Existing service consists of an underground service rated at 225A, 120/208V, 3Ø, 4 wire. The meter is located on the interior of the building below the panel. The main service consists of a 200A main circuit breaker panel located in the southwest corner of the garage bays.

The panel is original to the Building and was manufactured by Federal Pacific. This manufacturer no longer exists due to faulty breakers and fake UL testing results.

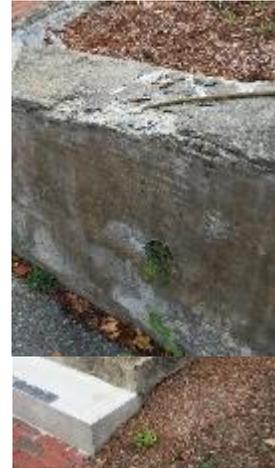
G2040 Site Development: The retaining wall at the south east approach to the entry walk requires repair.

Treatment Recommendation: Damaged areas should be removed, weeps cleaned out and if necessary part of the wall should be rebuilt. This effort should be tied to accessibility improvements to the front entry.

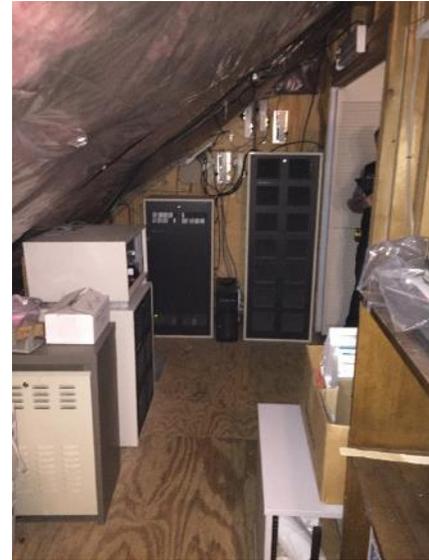
The remainder of the floor has 12" o.c. spacings and does meet code for live loading for corridors and office space but has little capacity to spare as the loading under the eaves is counted as dead load only. Expansion of the usable floor area by creating dormers will require strengthening the floor structure. This floor is covered by either VCT or carpeting. There are no signs of unexpected deterioration in areas covered by finish floors, so the floor deck in these areas is assumed in good condition as well. (exposed section of subfloor at the communication gear closet confirms this condition). All components of the second floor construction are in sound condition.

Treatment Recommendation: There is no visible displacement or deterioration of floor structure and no treatment is recommended at this point.

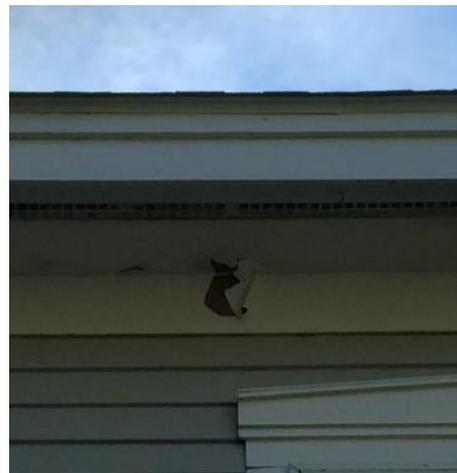
B2010 Exterior Walls: Walls are in good condition with the exception of the paint and caulk concerns in various areas.

1. The paint failures a certain spot areas should be scrapped spot primed and repainted. These spots are most notable on the north elevation.
2. The trim at various locations require caulking and paint touchup especially at corner boards, interior corners and at front entry porch columns and trim.
3. Wood stop trim at the overhead doors has deteriorated especially at the bottom sections.

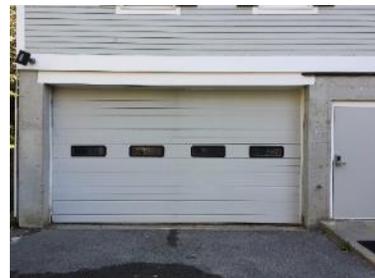
The door seals have failed in most locations

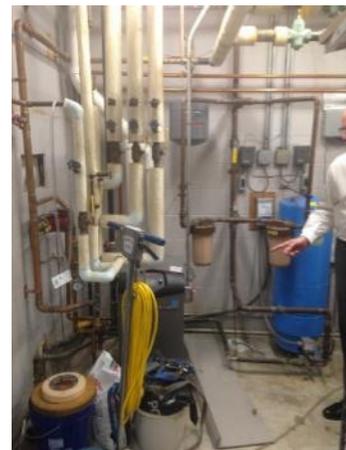
Mechanical Room: The heating plant consists of one (1) gas fired high efficiency Lochinvar boiler (not original to the building in 1986. The boiler supports three zones via circulator pumps and the indirect domestic hot water storage tank. Zone one supplies heat via baseboard fin-tube to the training, evidence and records room. Zones two supplies hydronic baseboard heat to the first level offices and lobby and zone three supplies the upper level office and meeting rooms. The entire system is in good condition with newer heating plant.

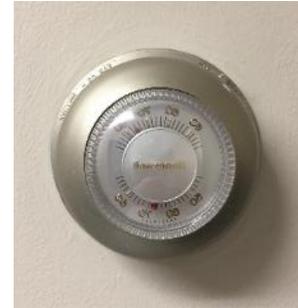
Automatic Temperature Control: Automatic temperature controls for the entire building are controlled via thermostats. All gas piping is fed down from the ceiling of the basement level. Honeywell thermostats are not programmable and are not connected to a building management system. Ventilation is provided by the exhaust fans in the public restroom and the locker rooms with roof mounted exhaust fans.

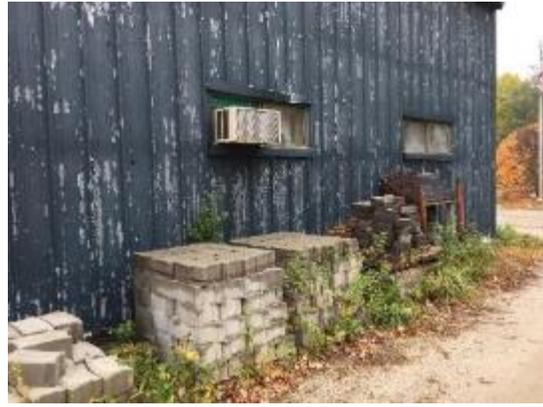
8. Office windows – window A/C unit

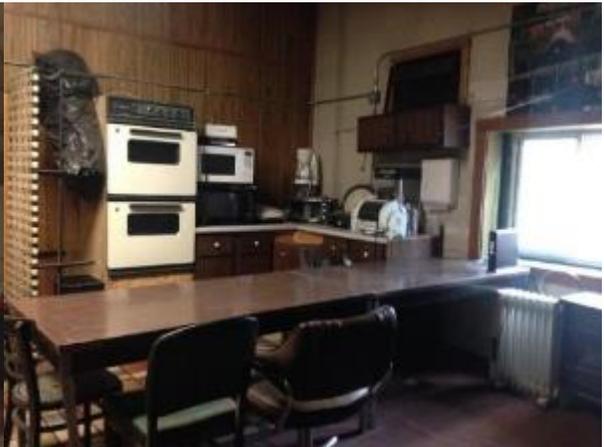
18. Second floor break room north corridor

All areas of the building appear to be in need of more space and in need of updating (photos 11, 18, 20, 21, 27). It was reported that the maintenance bay is in the most need of more space. However, we observed 7 rows of trucks and other vehicles parked two and three vehicles deep in the vehicle storage bays that are only served by three overhead doors. This requires careful maneuvering and ordering of vehicles to ensure the most efficient operation. It doesn't allow for ease of use, response, or ability to attach or load equipment inside. Office areas are cramped and the need for a second office has pushed the break and locker areas to the former storage loft and to the vehicle storage bays. Additionally desks and workbenches are placed in vehicle bays.

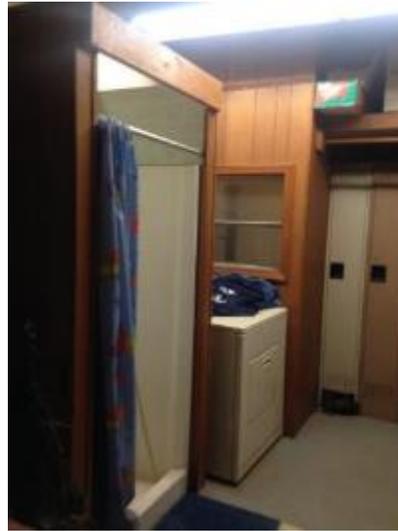
20. Locker and shower room

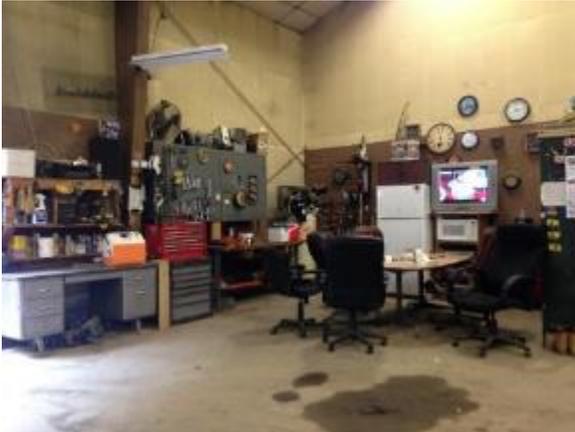
21. Break area in vehicle storage bay

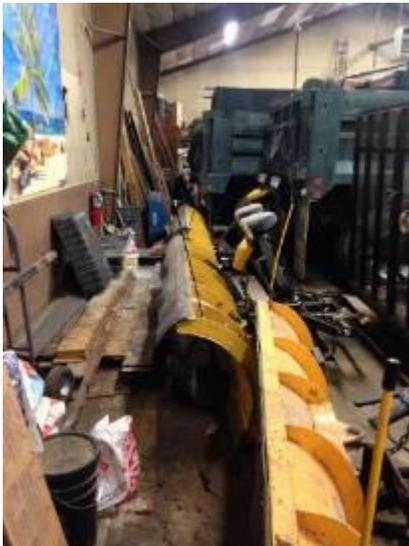
27. Equipment storage at south wall of vehicle bay

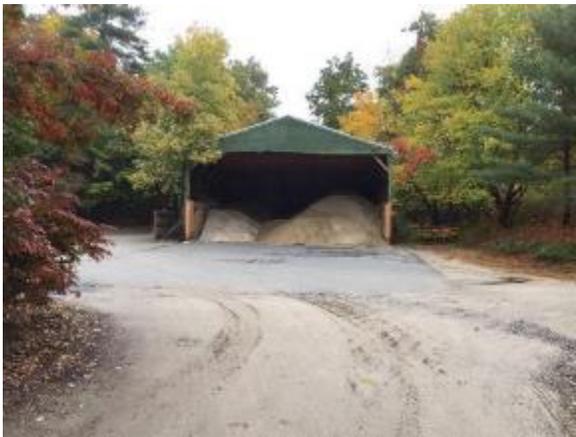
The salt shed (photo 33) is a wood pole structure with a pre-engineered truss roof. It is founded on a poured concrete slab and footings at the posts. Painted plywood clads the walls which are framed with horizontal 2x lumber. The cladding is in need of paint. Many of the plywood panels from the ground to just above the buttresses have rot from constant damp and age. Three sides of the structure are fully clad and enclosed, leaving the west gable end open to the weather. Corrugated roofing spans between the joists on 2x wood purlins. Roofing appears in good condition. The lower eight feet of the shed are reinforced with paired 2x diagonal buttresses. Several of these buttresses have failed or are rotting (photo 36). They should be replaced and reinforced. Planks clad the interior of the structure at the bottom 8' for

reinforcing and ease of loading and unloading salt by loader. These planks are in fair condition, however they don't currently go as high as the salt is piled. Some of the lowest planks have been badly damaged via a combination of rot and vehicle impacts (photos 34, 35). Planks should be replaced and should be installed to a greater height to prevent further damage to the shed's structure and cladding. Continuous overloading of the shed will lead to further structural and cladding damage by rot and impact. The structure is undersized by about 50% for its current demand.

33. Salt shed open end

The salt shed should be expanded. Current overloading is accelerating the building's deterioration. Staff estimates that 50% increase is needed. Expansion is easiest at either of the gable ends and would involve adding bays in a similar construction as exists. There appears to be some room on the site that would allow for this expansion without impacting current vehicle travel lanes.

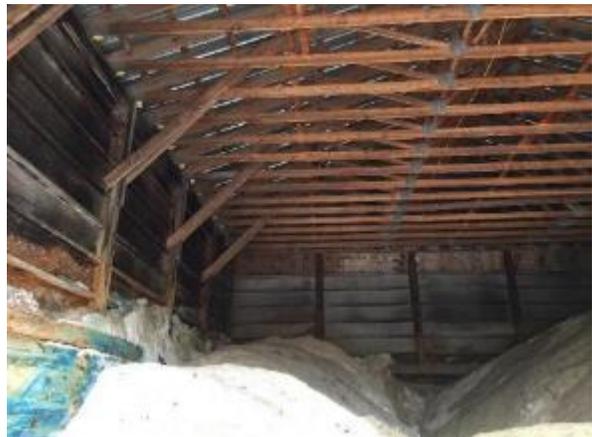
34. Salt shed structure and top of salt pile

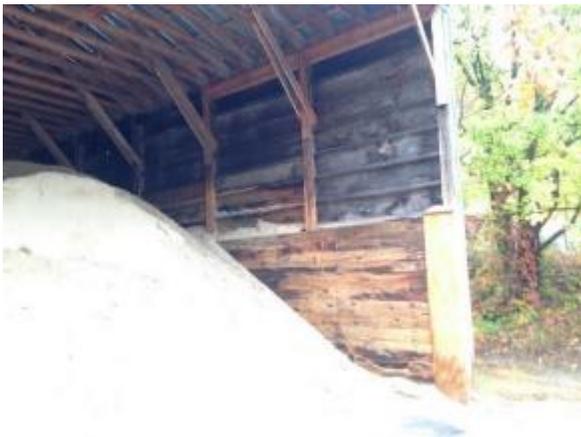
35. Salt shed sidewall

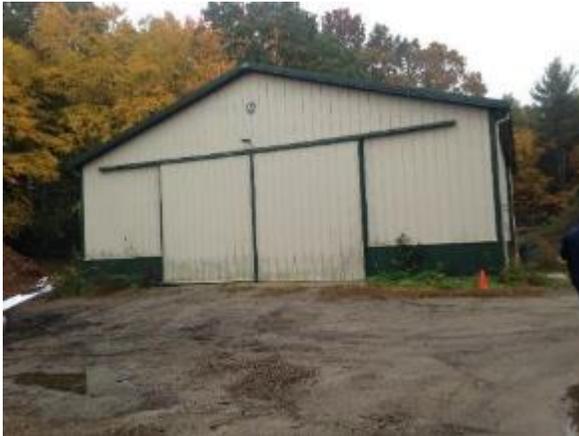
37. Morton building gable end

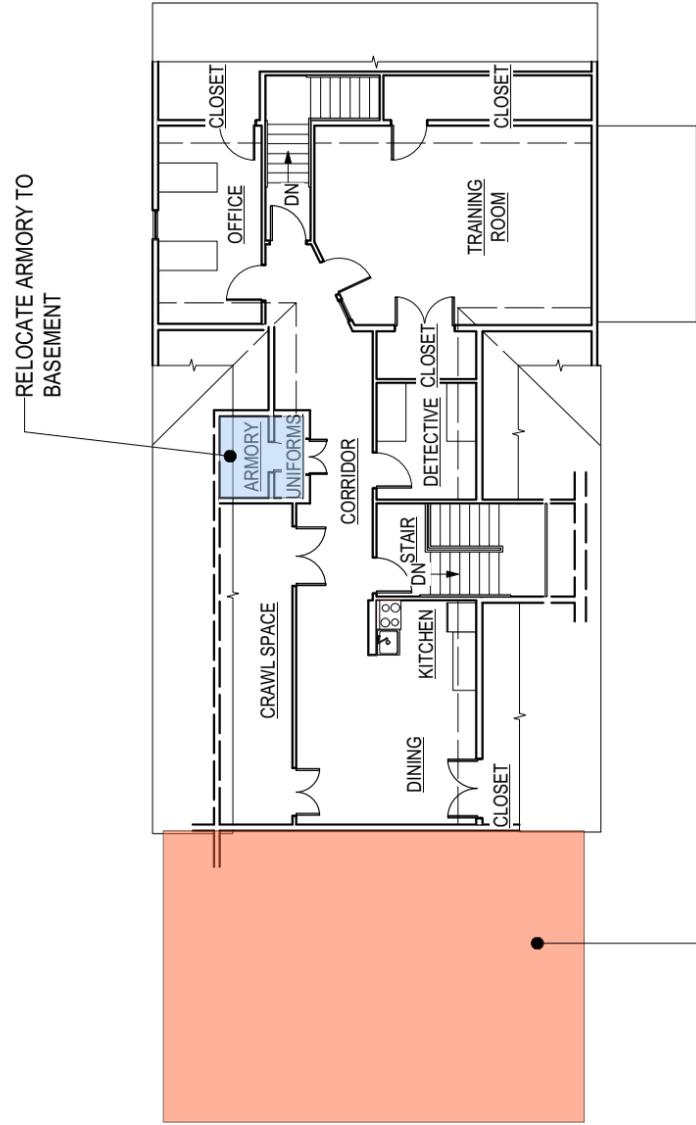
CONCEPTUAL SECOND FLOOR PLAN

NEW DETECTIVE & INTERVIEW
NEW STORAGE

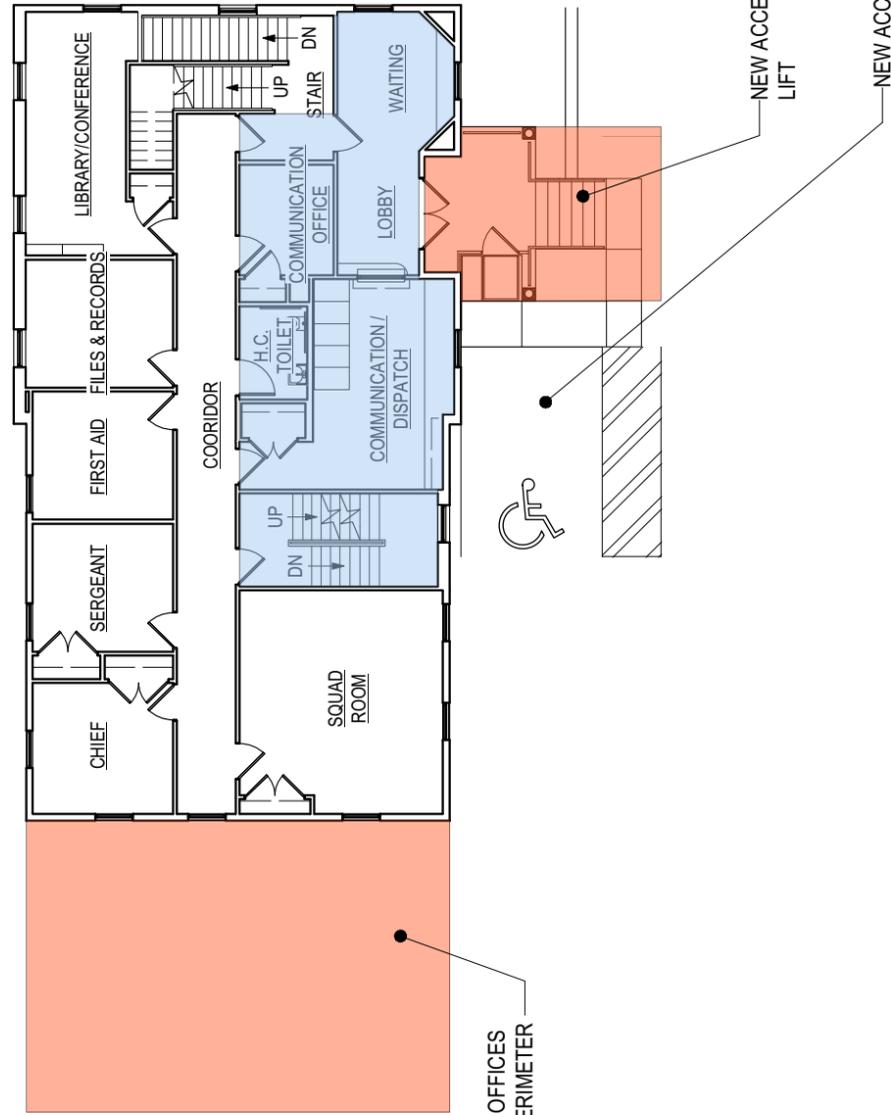
CONCEPTUAL FIRST FLOOR PLAN

EXPAND ADMINISTRATION OFFICES
RECONFIGURE SECURE PERIMETER

NEW ACCESSIBLE ENTRY W/
LIFT
NEW ACCESSIBLE PARKING

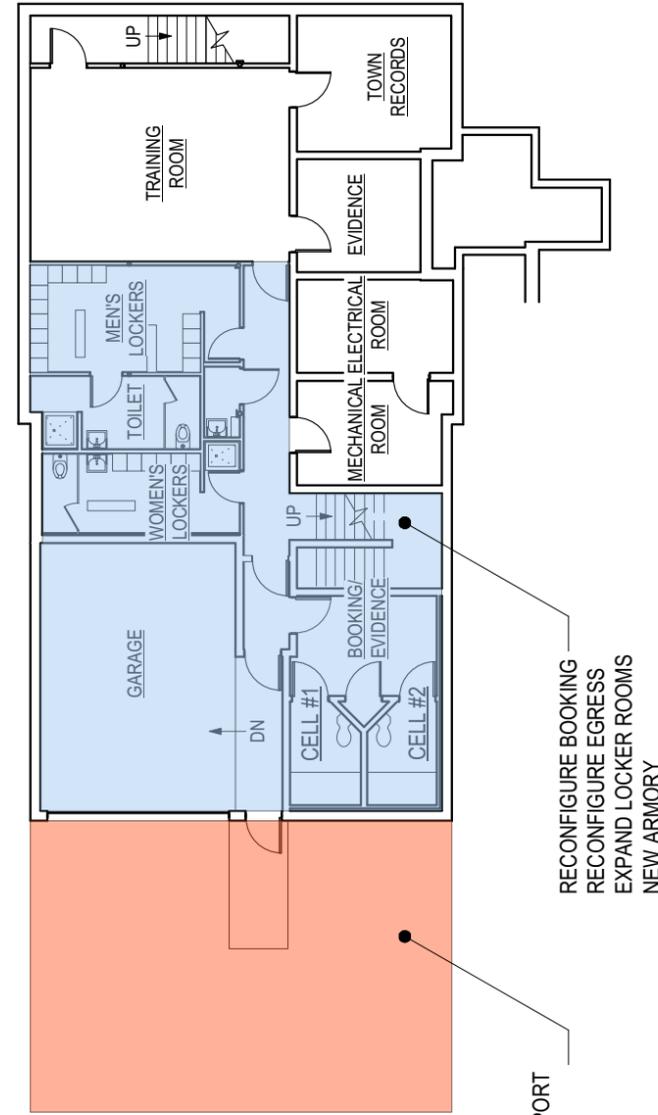
NEW 2 BAY SALLY PORT

RECONFIGURE BOOKING
RECONFIGURE EGRESS
EXPAND LOCKER ROOMS
NEW ARMORY
